Waterbody Data Sheet

Description			
Project Name: Line 5 Relocation Project		Date: 2019-09-06	Waterbody Survey ID: sasa004p
State: WI	County/Parish: Ashland	USGS Waterbody Name: UNT to Gehrman Creek	
Company: Enbridge	Crew Member Initials: NTT/DGL	Latitude: 46.365579	Longitude: -90.588129
Survey Type: <input checked="" type="checkbox"/> Centerline <input type="checkbox"/> Re-Route <input type="checkbox"/> Access Road <input type="checkbox"/> Facility <input type="checkbox"/> Other <small>(check one)</small>			
Waterbody Type: <input type="checkbox"/> River <input checked="" type="checkbox"/> Stream <input type="checkbox"/> Ditch <input type="checkbox"/> Swale <input type="checkbox"/> Canal <input type="checkbox"/> Other <small>(check one)</small>			
Water Appearance: <input type="checkbox"/> No Water <input checked="" type="checkbox"/> Clear <input type="checkbox"/> Turbid <input type="checkbox"/> Sheen on Surface <input type="checkbox"/> Surface Scum <input type="checkbox"/> Algal Mats <input type="checkbox"/> Other <small>(check one)</small>

APPENDIX F

Waterbody Data Sheets

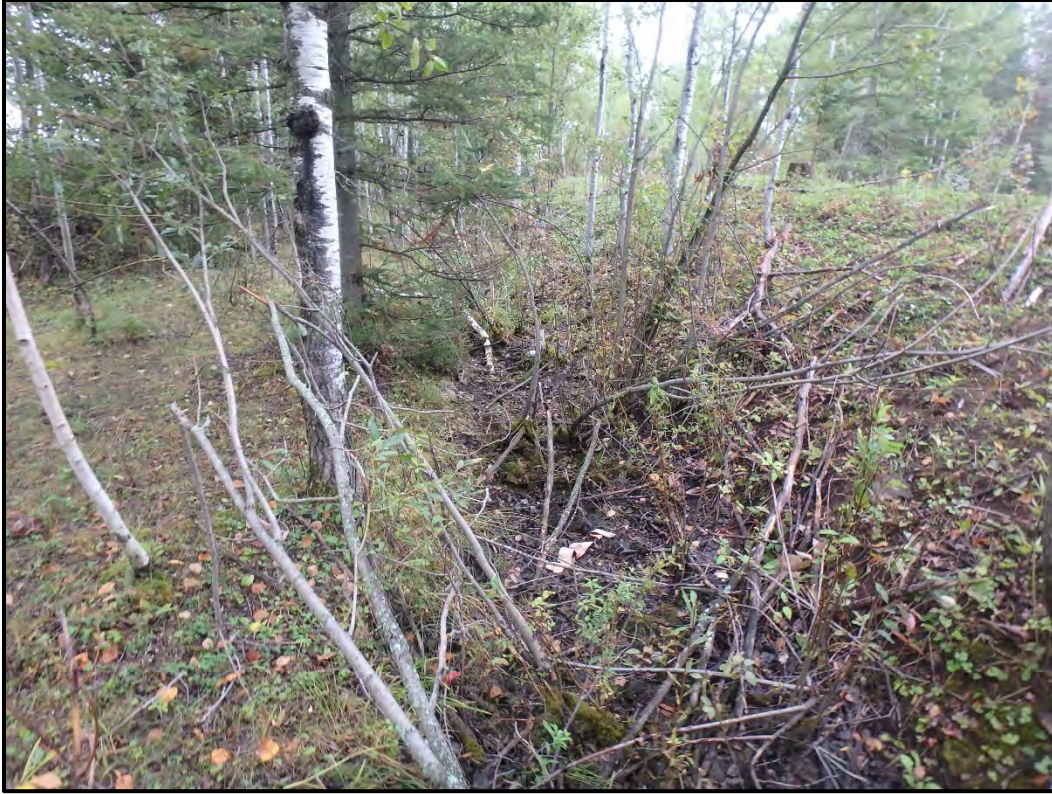
sasa017e_E (downstream)

Vegetation Layers: <input checked="" type="checkbox"/> Trees <input checked="" type="checkbox"/> Saplings/Shrubs <input checked="" type="checkbox"/> Herbs <small>(check all that apply)</small>			
Dominant Bank Vegetation (list): Populus tremuloides, Fraxinus pennsylvanica, Salix petiolaris, Carex intumescens, Abies balsamea.			
Aquatic Habitats (ex: submerged or emerged aquatic vegetation, overhanging banks/roots, leaf packs, large submerged wood, riffles, deep pools, etc.): None.			
Aquatic Organisms Observed (list): None.			
Disturbances (ex: livestock access, manure in waterbody, waste discharge pipes): Large man-made berm. Abundant fallen trees and debris.			
Observation Notes: No water present at time of survey.

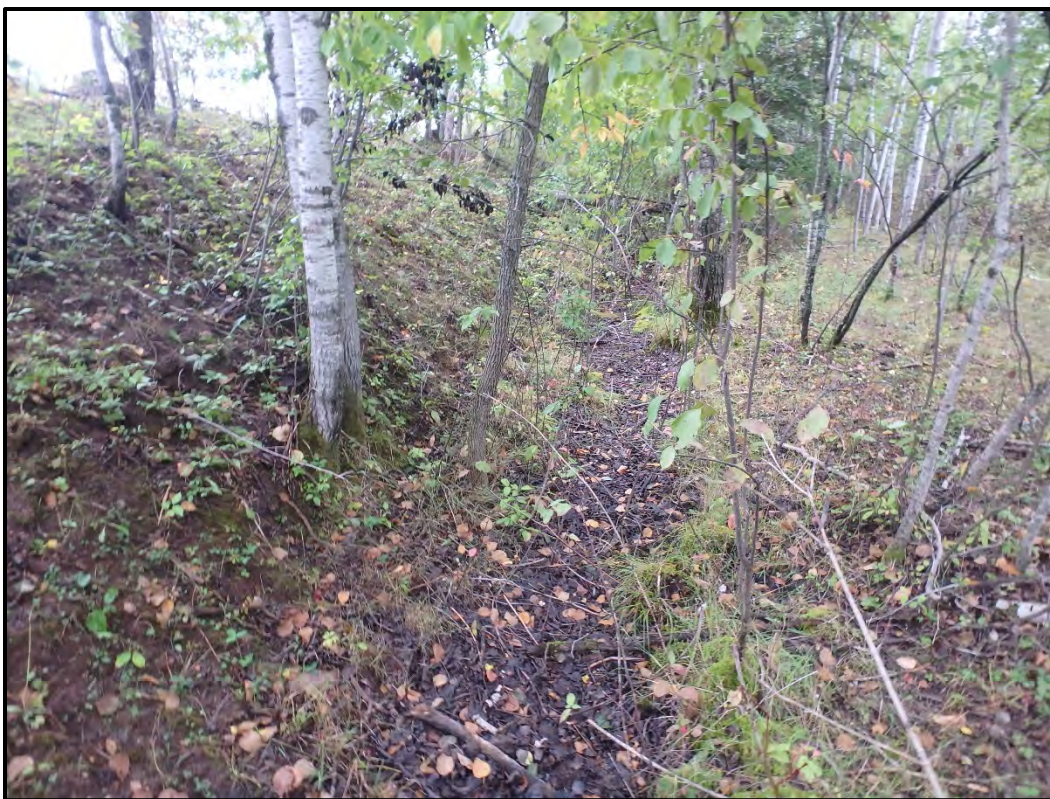
sasa018e_E (downstream)

Vegetation Layers: <input checked="" type="checkbox"/> Trees <input checked="" type="checkbox"/> Saplings/Shrubs <input checked="" type="checkbox"/> Herbs <small>(check all that apply)</small>			
Dominant Bank Vegetation (list): Banks dominated by Populus tremuloides and Fraxinus nigra.			
Aquatic Habitats (ex: submerged or emerged aquatic vegetation, overhanging banks/roots, leaf packs, large submerged wood, riffles, deep pools, etc.): None.			
Aquatic Organisms Observed (list): None.			
Disturbances (ex: livestock access, manure in waterbody, waste discharge pipes): Erosion.			
Observation Notes: Channel covered by leaves and other decaying material. No water present at time of survey.

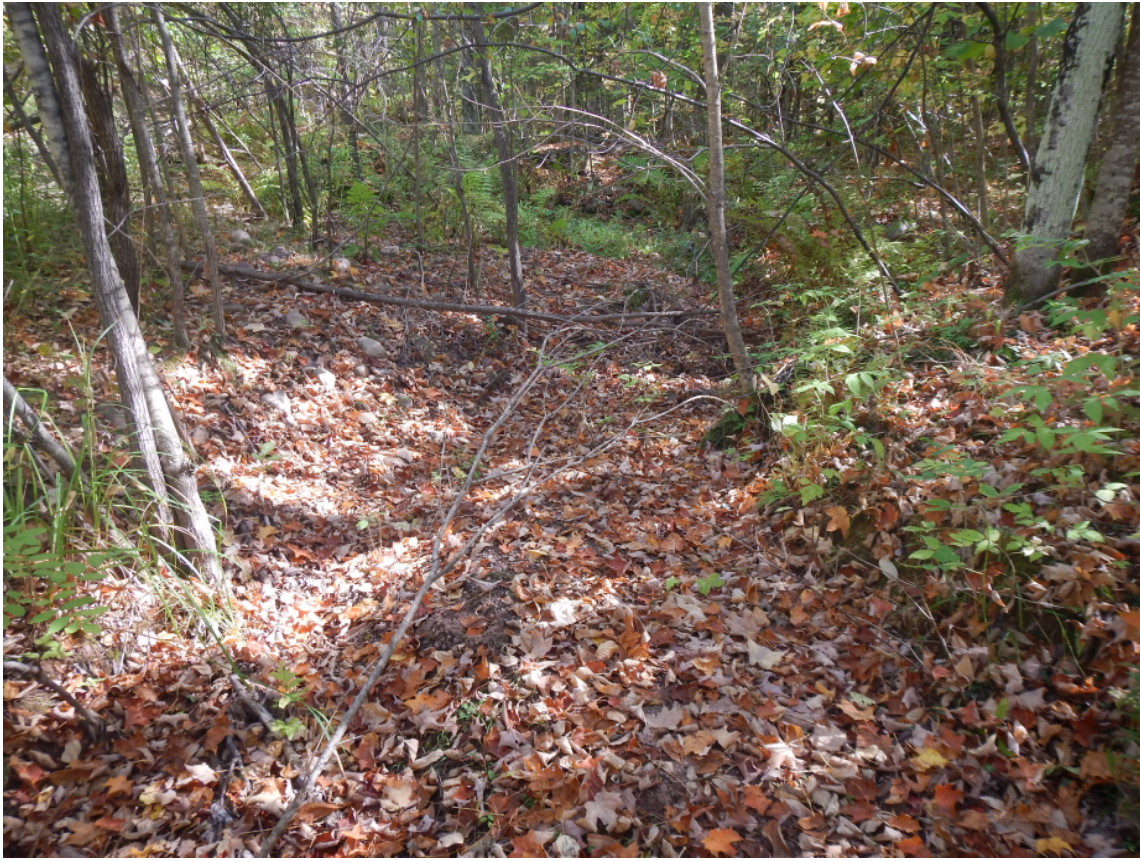
sasw008

No flow, little aquatic habitat, little herbaceous layer

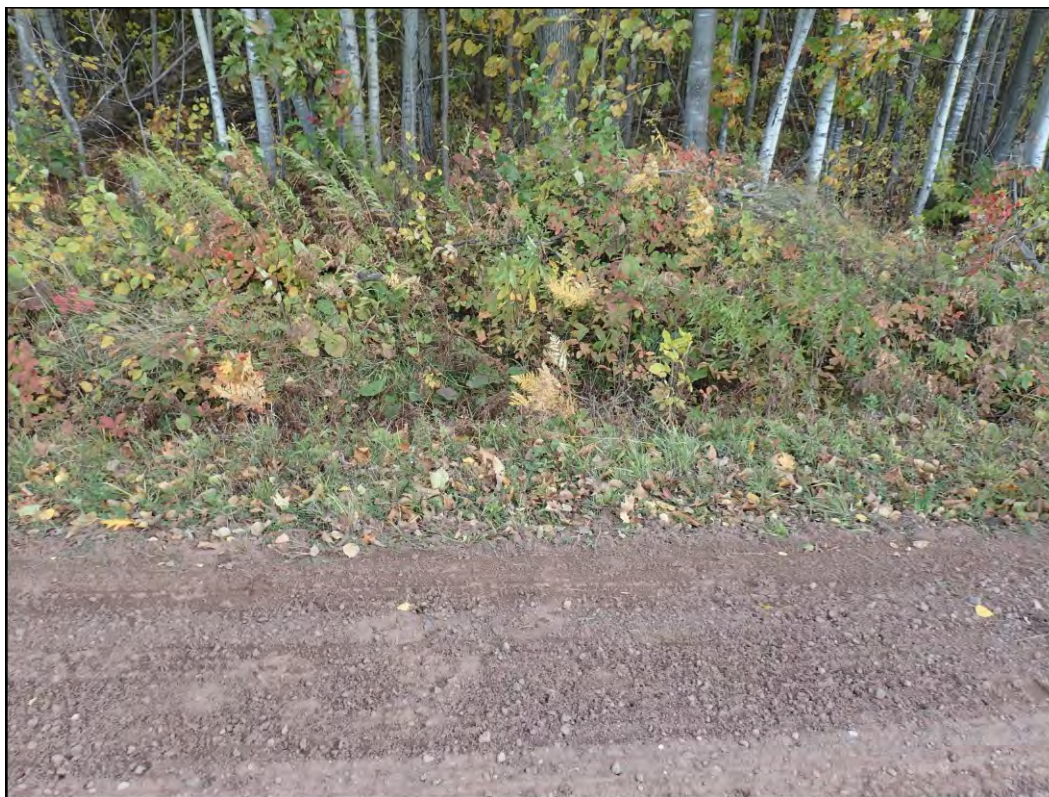
sirb015e_E (across)

Vegetation Layers: <input type="checkbox"/> Trees <input checked="" type="checkbox"/> Saplings/Shrubs <input checked="" type="checkbox"/> Herbs <small>(check all that apply)</small>			
Dominant Bank Vegetation (list): Eurybia macrophylla, Phalaris arundinacea, Poa pratensis, Pteridium aquilinum, Scirpus cyperinus. Adjacent to a mesic hardwood system.			
Aquatic Habitats (ex: submerged or emerged aquatic vegetation, overhanging banks/roots, leaf packs, large submerged wood, riffles, deep pools, etc.): None.			
Aquatic Organisms Observed (list): None.			
Disturbances (ex: livestock access, manure in waterbody, waste discharge pipes): Artificial in origin.			
Observation Notes: Feature continues outside the survey corridor.

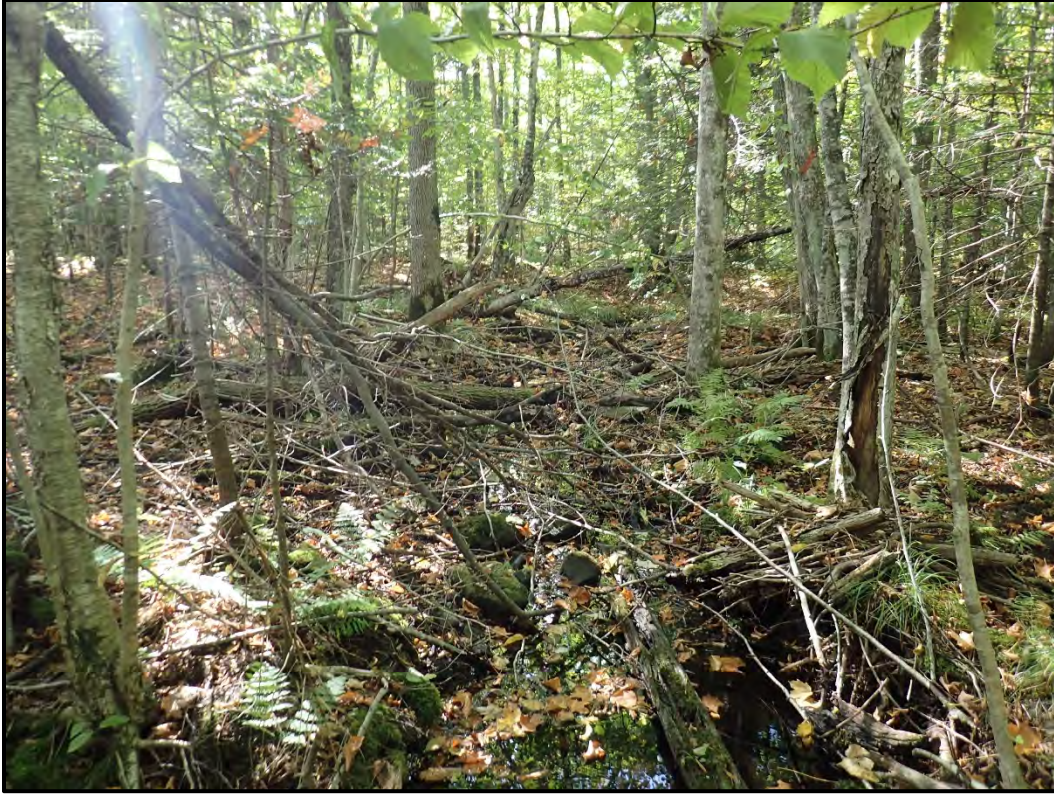
sirb010p_E (upstream)

Vegetation Layers: <input checked="" type="checkbox"/> Trees <input checked="" type="checkbox"/> Saplings/Shrubs <input checked="" type="checkbox"/> Herbs <small>(check all that apply)</small>					
Dominant Bank Vegetation (list): The banks include Fraxinus nigra, Ulmus americana, Acer saccharum, and Tilia americana. The herbaceous layer contains Osmunda claytoniana, Athyrium filix-femina, Carex gracillima, and Carex pedunculata.					
Aquatic Habitats (ex: submerged or emerged aquatic vegetation, overhanging banks/roots, leaf packs, large submerged wood, riffles, deep pools, etc.): Shallow running water as well as pools of standing water are present.					
Aquatic Organisms Observed (list): Water striders.					
Disturbances (ex: livestock access, manure in waterbody, waste discharge pipes): The feature experiences erosion along its banks.					
Observation Notes: The waterbody continues out of the black ash swamp to sirb009p which is adjacent to an unpaved road.

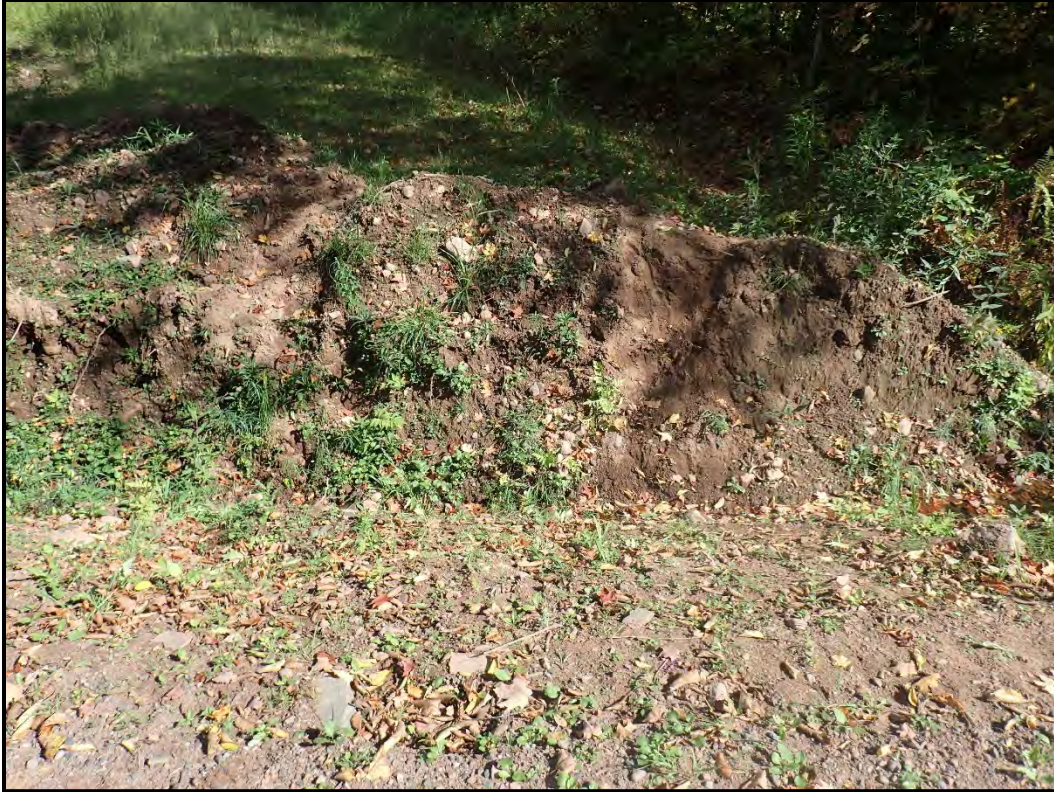
sirb009p_E (across)

Observations			
Riparian Zone Present: <input type="checkbox"/> Yes <input checked="" type="checkbox"/> No <small>(check one)</small>			
Vegetation Layers: <input checked="" type="checkbox"/> Trees <input checked="" type="checkbox"/> Saplings/Shrubs <input checked="" type="checkbox"/> Herbs <small>(check all that apply)</small>			
Dominant Bank Vegetation (list): Acer saccharum, Ulmus americana, Athyrium filix-femina, Tilia americana.			
Aquatic Habitats (ex: submerged or emerged aquatic vegetation, overhanging banks/rocks, leaf packs, large submerged wood, riffles, deep pools, etc.): Small pools of water dispersed throughout swale as well as portions of running water.			
Aquatic Organisms Observed (list): Frogs, water striders.			
Disturbances (ex: livestock access, manure in waterbody, waste discharge pipes): Erosion along the banks exposing tree roots. Runoff from roadway.			
Observation Notes: Portions of the waterbody susceptible to erosion; banks heavily incised at points.

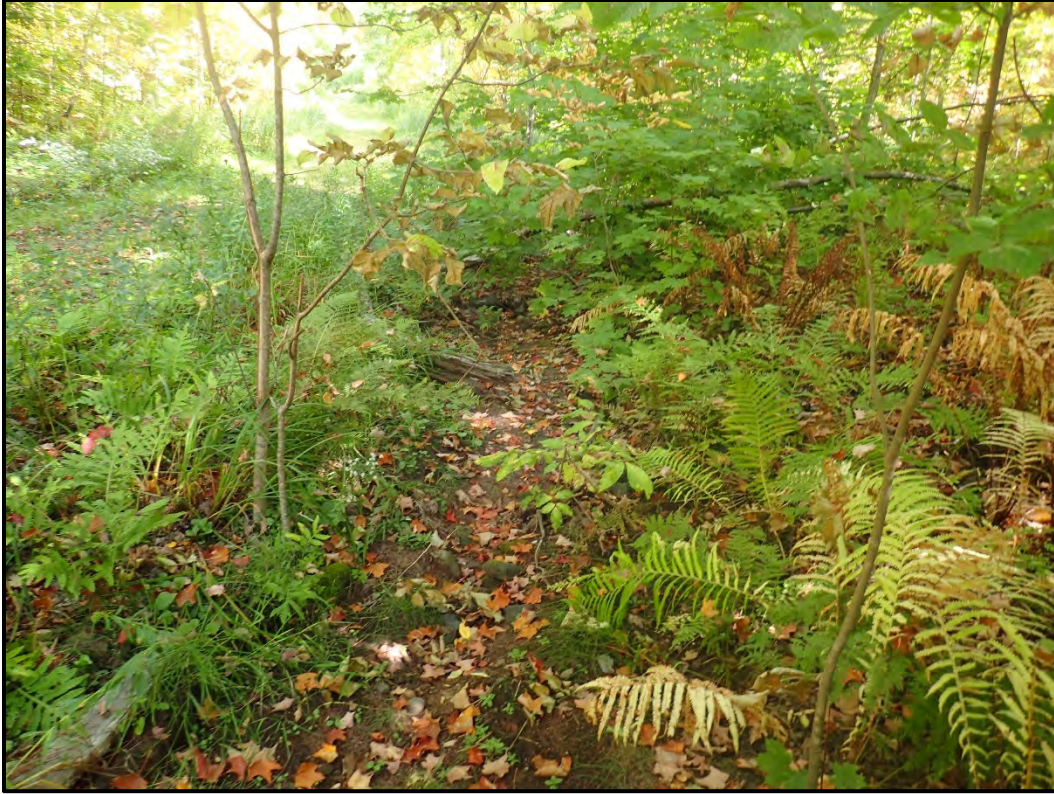
sirb008e_E (upstream)

Vegetation Layers: <input checked="" type="checkbox"/> Trees <input checked="" type="checkbox"/> Saplings/Shrubs <input checked="" type="checkbox"/> Herbs <small>(check all that apply)</small>			
Dominant Bank Vegetation (list): Acer saccharum, Ulmus americana, Dryopteris intermedia.			
Aquatic Habitats (ex: submerged or emerged aquatic vegetation, overhanging banks/roots, leaf packs, large submerged wood, riffles, deep pools, etc.): None.			
Aquatic Organisms Observed (list): None.			
Disturbances (ex: livestock access, manure in waterbody, waste discharge pipes): Disturbances include the OHV trail.			
Observation Notes: There is no standing water at the time of survey.

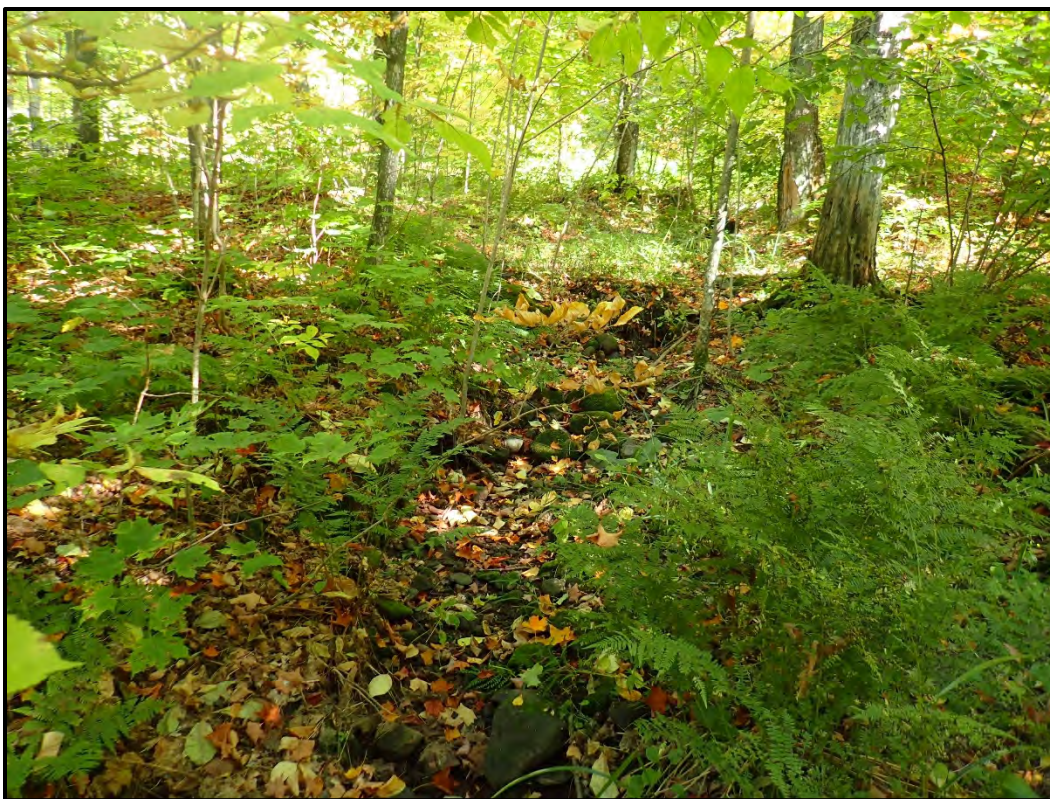
sirb006e_E (downstream)

Vegetation Layers: <input checked="" type="checkbox"/> Trees <input checked="" type="checkbox"/> Saplings/Shrubs <input checked="" type="checkbox"/> Herbs <small>(check all that apply)</small>			
Dominant Bank Vegetation (list): The feature runs through the margin of a mesic hardwood forest. Dominant bank vegetation includes Athyrium filix-femina, Acer saccharum, and Fraxinus nigra.			
Aquatic Habitats (ex: submerged or emerged aquatic vegetation, overhanging banks/roots, leaf packs, large submerged wood, riffles, deep pools, etc.): None.			
Aquatic Organisms Observed (list): None.			
Disturbances (ex: livestock access, manure in waterbody, waste discharge pipes): None.			
Observation Notes: There is no water present at the time of survey.

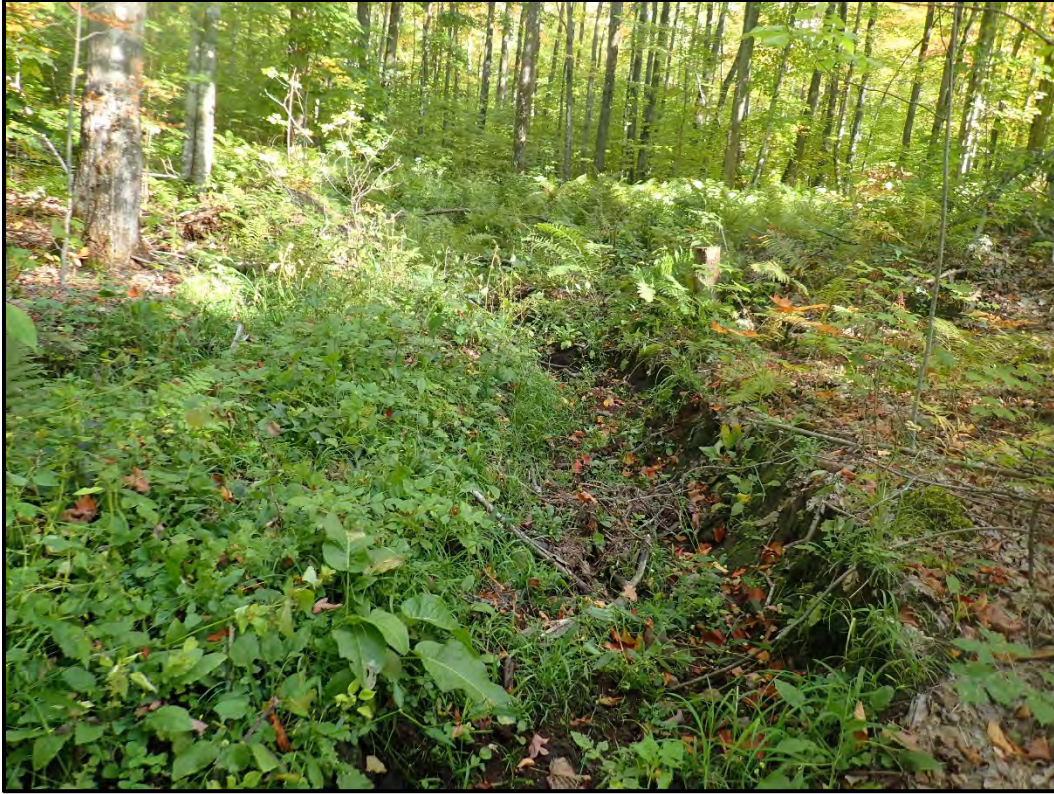
sirb007e_E (upstream)

Vegetation Layers: <input checked="" type="checkbox"/> Trees <input checked="" type="checkbox"/> Saplings/Shrubs <input checked="" type="checkbox"/> Herbs <small>(check all that apply)</small>			
Dominant Bank Vegetation (list): The swale runs through a mesic hardwood forest.			
Aquatic Habitats (ex: submerged or emerged aquatic vegetation, overhanging banks/roots, leaf packs, large submerged wood, riffles, deep pools, etc.): None.			
Aquatic Organisms Observed (list): None.			
Disturbances (ex: livestock access, manure in waterbody, waste discharge pipes): The banks of the feature are eroded, exposing shrub roots.			
Observation Notes: The swale runs adjacent to an access road. There is no water present at the time of survey.

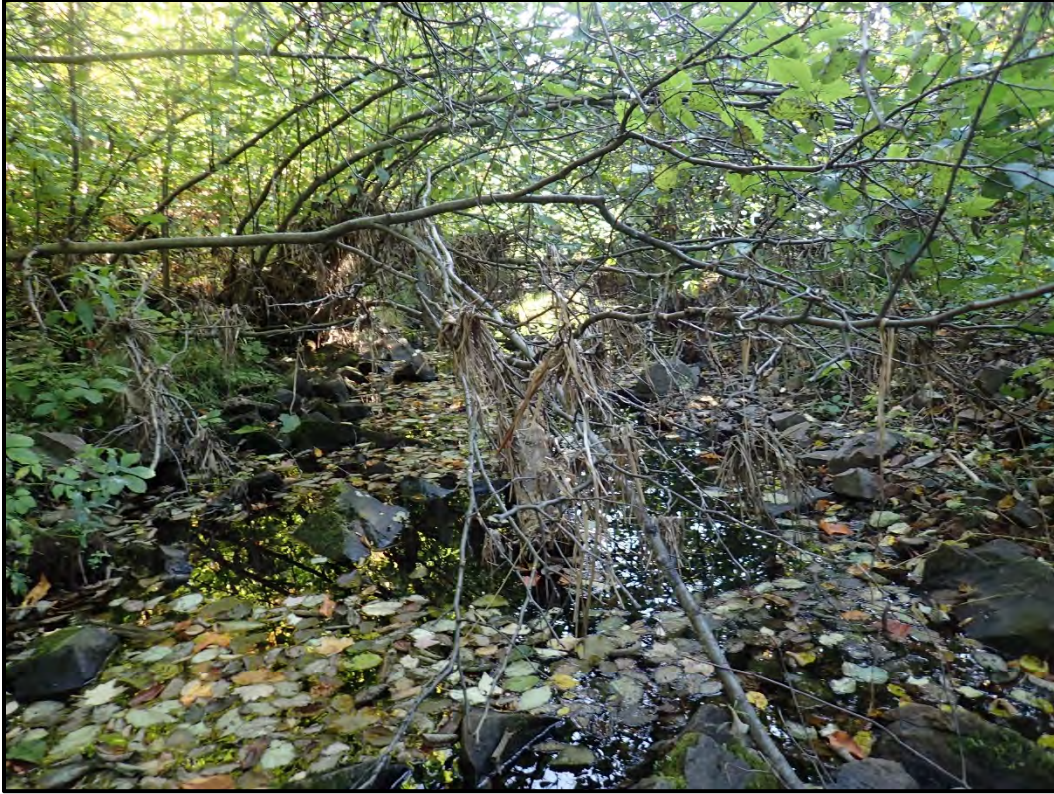
sirb005p_E (downstream)

Observation Notes: The feature runs roughly N-S before dissipating into wetland wirb015. The feature is also associated with a beaver impoundment.

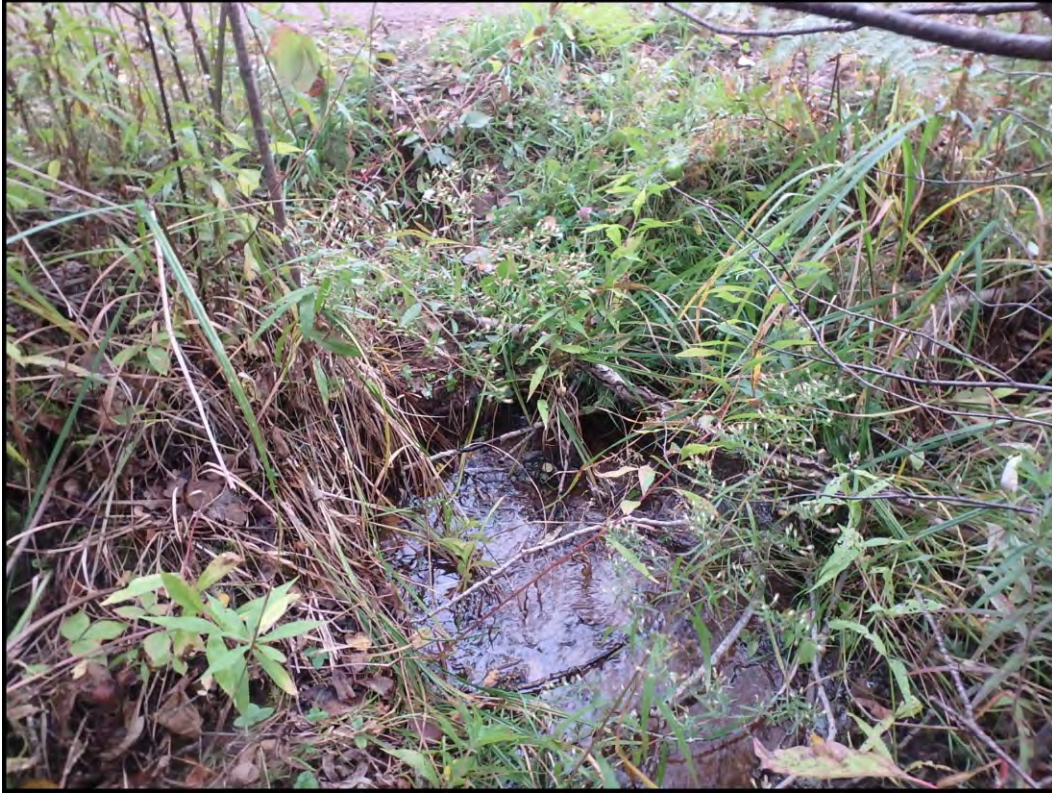
sasc031i_E (upstream)

Vegetation Layers: <input checked="" type="checkbox"/> Trees <input checked="" type="checkbox"/> Saplings/Shrubs <input checked="" type="checkbox"/> Herbs <i>(check all that apply)</i>			
Dominant Bank Vegetation (list): Populus tremuloides, Alnus incana, Glyceria striata, Carex crinita, Symphyotrichum lateriflorum.			
Aquatic Habitats (ex: submerged or emerged aquatic vegetation, overhanging banks/roots, leaf packs, large submerged wood, riffles, deep pools, etc.): Overhanging vegetation.			
Aquatic Organisms Observed (list): None.			
Disturbances (ex: livestock access, manure in waterbody, waste discharge pipes): Runoff from dirt road.			
Observation Notes: The stream has been somewhat affected by the dirt road.

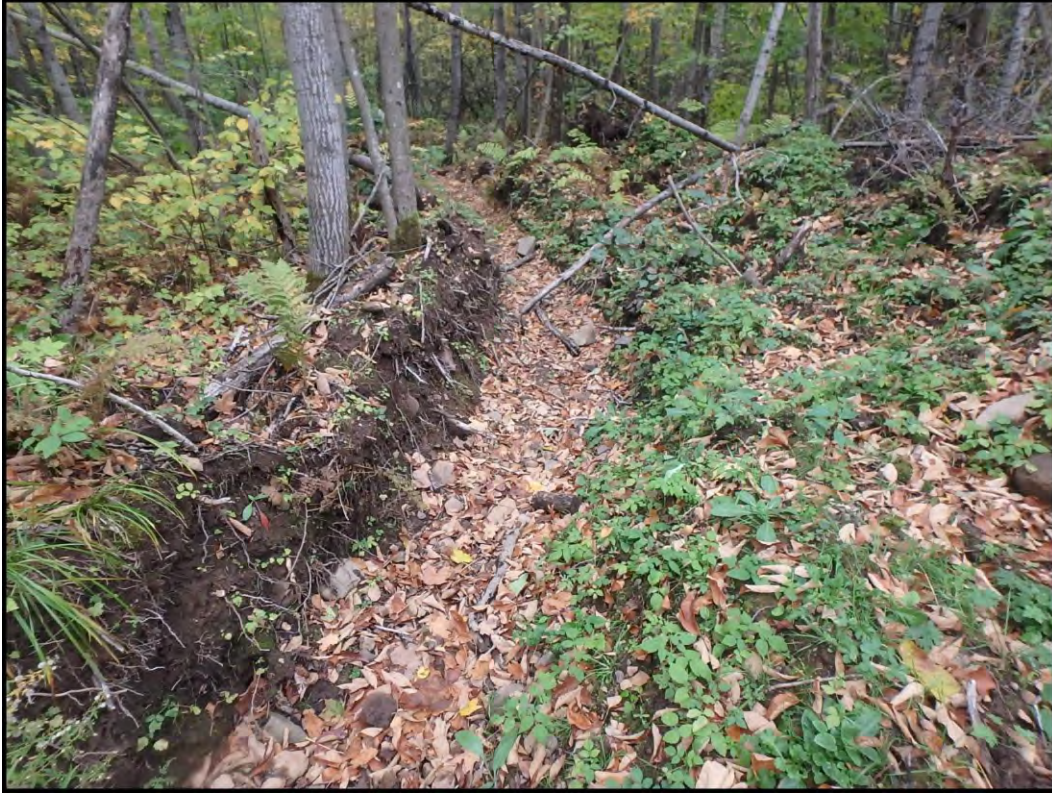
sirc006e_NW (upstream)

Observations			
Riparian Zone Present: <input type="checkbox"/> Yes <input checked="" type="checkbox"/> No <small>(check one)</small>			
Vegetation Layers: <input checked="" type="checkbox"/> Trees <input type="checkbox"/> Saplings/Shrubs <input checked="" type="checkbox"/> Herbs <small>(check all that apply)</small>			
Dominant Bank Vegetation (list): Populus tremuloides, Fraxinus nigra, Rubus idaeus, Osmunda claytoniana, Hypericum perforatum, Oenothera biennis.			
Aquatic Habitats (ex: submerged or emerged aquatic vegetation, overhanging banks/roots, leaf packs, large submerged wood, riffles, deep pools, etc.): None.			
Aquatic Organisms Observed (list): None.			
Disturbances (ex: livestock access, manure in waterbody, waste discharge pipes): Erosion, runoff from gravel road, culverts.			
Observation Notes: The feature is artificial and of low quality, and is associated with several ditches.

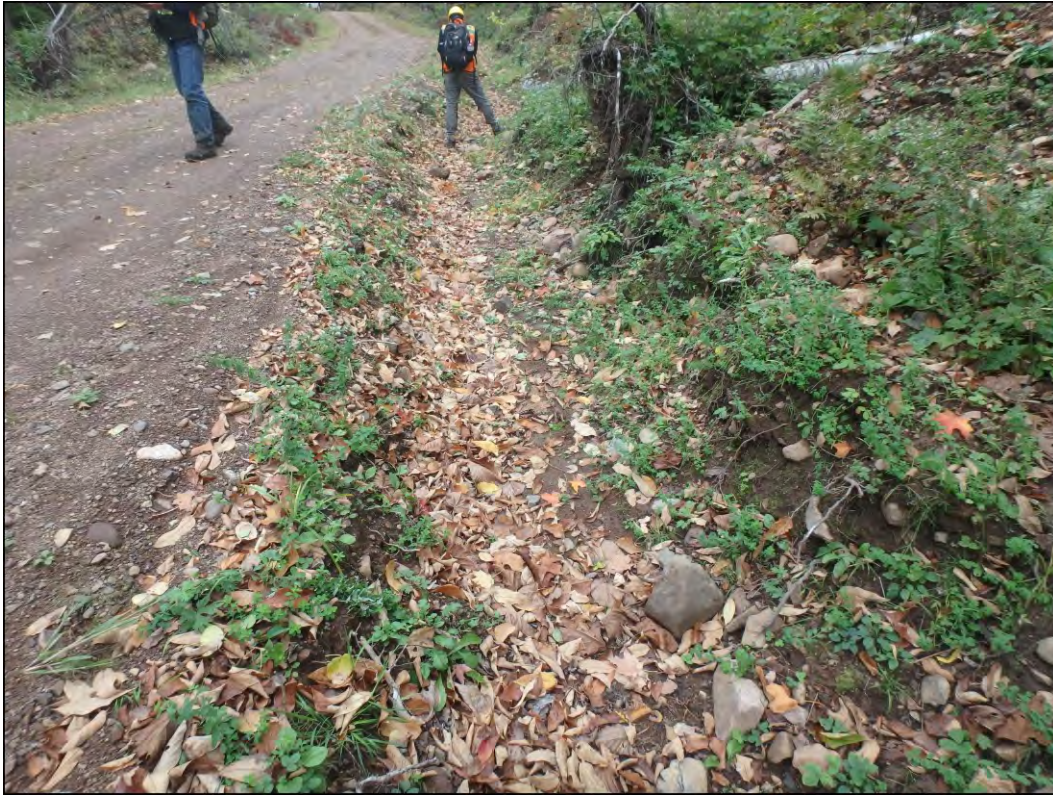
sire002e_NE (upstream)

Observations			
Riparian Zone Present: <input type="checkbox"/> Yes <input checked="" type="checkbox"/> No <small>(check one)</small>			
Vegetation Layers: <input type="checkbox"/> Trees <input type="checkbox"/> Saplings/Shrubs <input type="checkbox"/> Herbs <small>(check all that apply)</small>			
Dominant Bank Vegetation (list): No vegetation throughout ditch.			
Aquatic Habitats (ex: submerged or emerged aquatic vegetation, overhanging banks/roots, leaf packs, large submerged wood, riffles, deep pools, etc.): None.			
Aquatic Organisms Observed (list): None.			
Disturbances (ex: livestock access, manure in waterbody, waste discharge pipes): Recently excavated.			
Observation Notes: None.

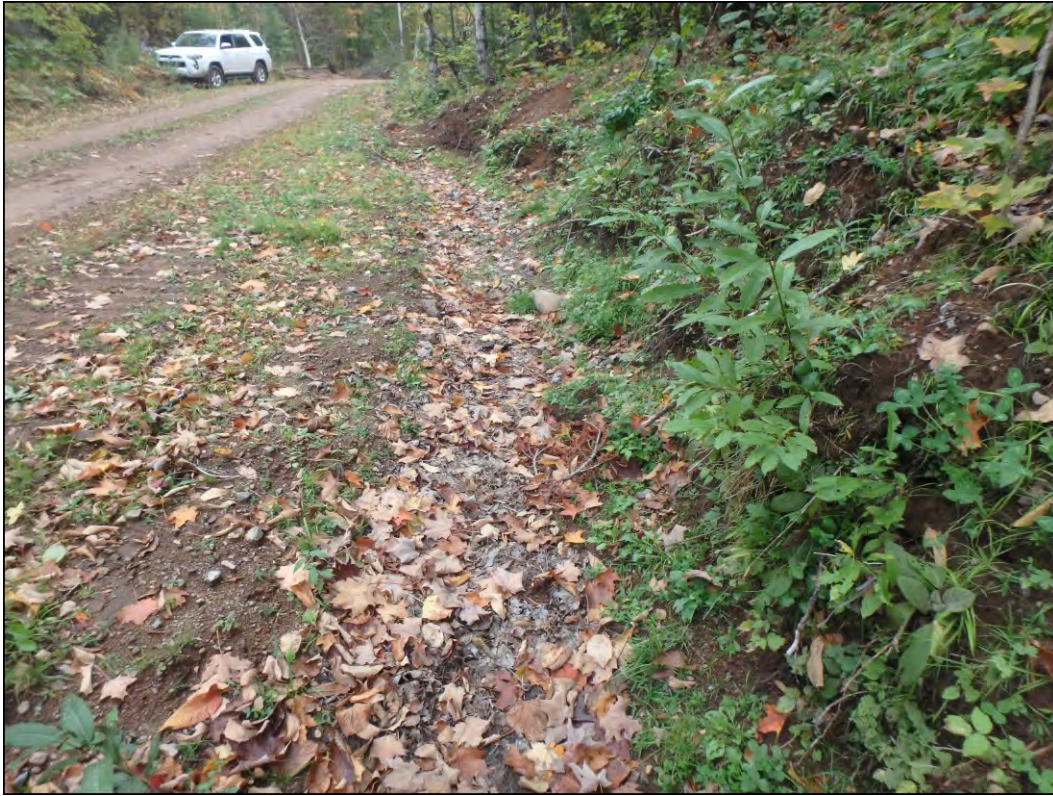
sire003e_NE (upstream)

Vegetation Layers: <input type="checkbox"/> Trees <input type="checkbox"/> Saplings/Shrubs <input type="checkbox"/> Herbs <i>(check all that apply)</i>			
Dominant Bank Vegetation (list): No vegetation present.			
Aquatic Habitats (ex: submerged or emerged aquatic vegetation, overhanging banks/roots, leaf packs, large submerged wood, riffles, deep pools, etc.): None.			
Aquatic Organisms Observed (list): None.			
Disturbances (ex: livestock access, manure in waterbody, waste discharge pipes): Waterbody was recently excavated.			
Observation Notes: None.

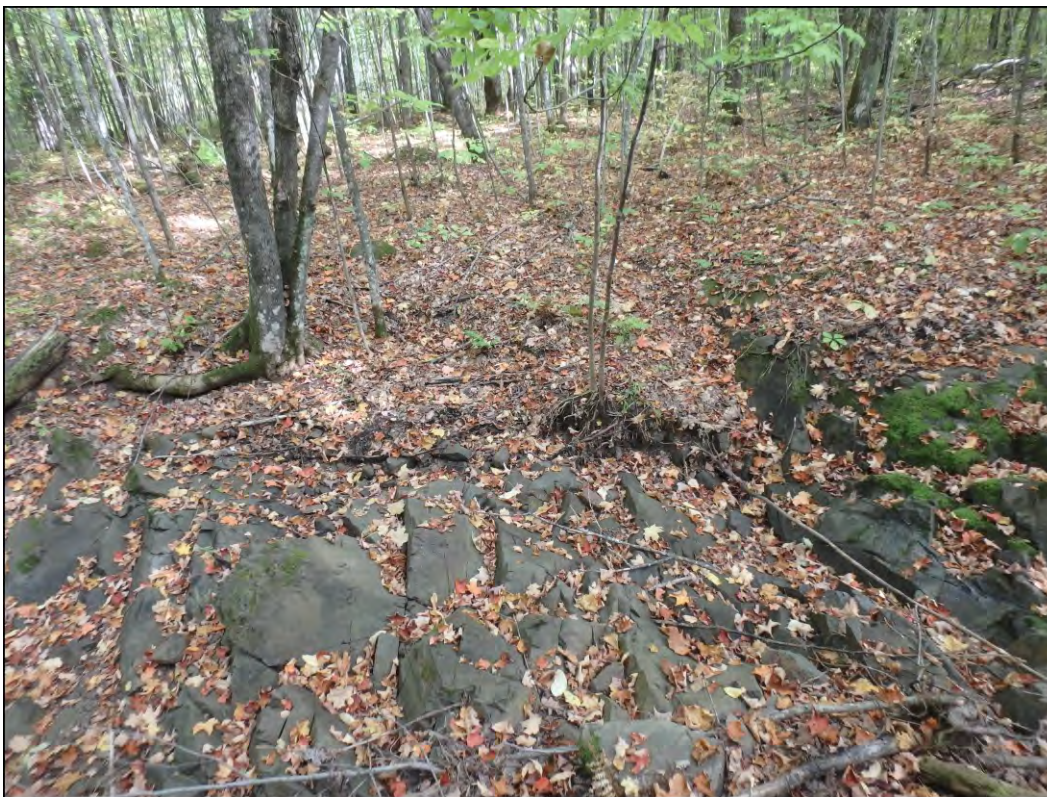
sird010e_E (across)

Vegetation Layers: <input checked="" type="checkbox"/> Trees <input checked="" type="checkbox"/> Saplings/Shrubs <input checked="" type="checkbox"/> Herbs <small>(check all that apply)</small>			
Dominant Bank Vegetation (list): Fraxinus nigra, Athyrium angustum, Calamagrostis canadensis.			
Aquatic Habitats (ex: submerged or emerged aquatic vegetation, overhanging banks/roots, leaf packs, large submerged wood, riffles, deep pools, etc.): None.			
Aquatic Organisms Observed (list): None.			
Disturbances (ex: livestock access, manure in waterbody, waste discharge pipes): Logging road.			
Observation Notes: The feature is a narrow ephemeral stream located within a larger swale. There is a logging road to the south of the feature that impacts the flow.

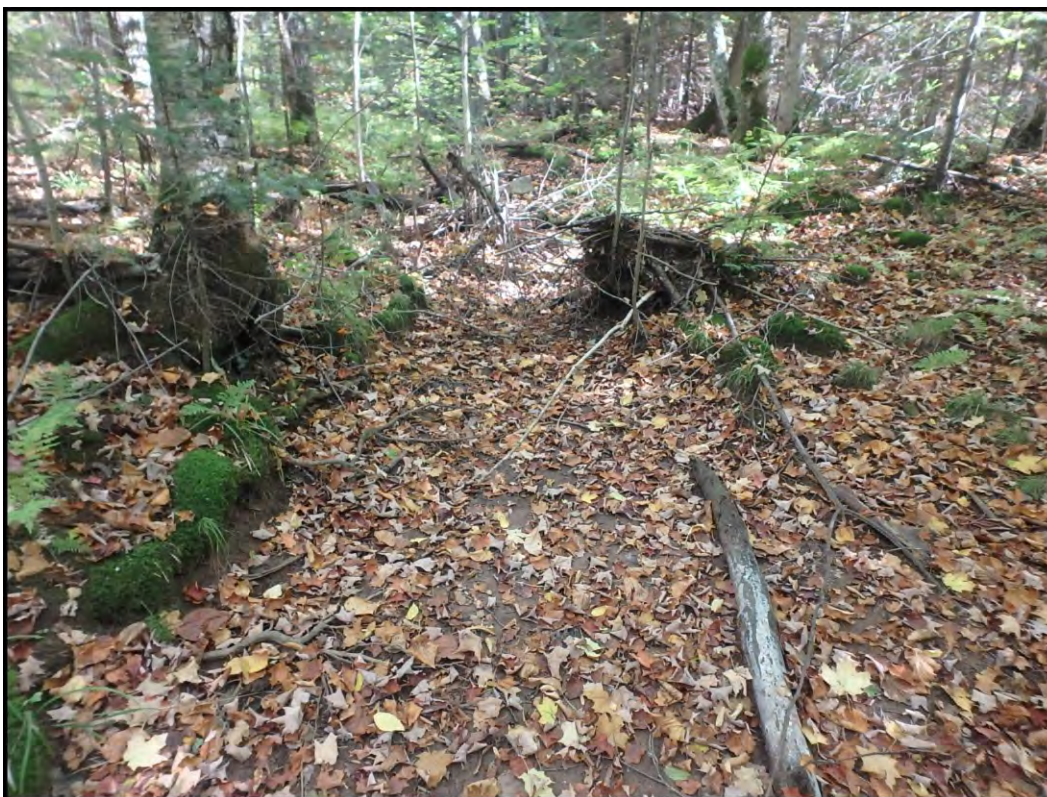
sirc005e_E (downstream)

Observations			
Riparian Zone Present: <input checked="" type="checkbox"/> Yes <input type="checkbox"/> No <small>(check one)</small>			
Vegetation Layers: <input checked="" type="checkbox"/> Trees <input checked="" type="checkbox"/> Saplings/Shrubs <input checked="" type="checkbox"/> Herbs <small>(check all that apply)</small>			
Dominant Bank Vegetation (list): Acer saccharum, Tilia americana, Betula alleghaniensis, Fraxinus nigra, Lycopodium uniflorum, Athyrium angustum, Carex gracillima.			
Aquatic Habitats (ex: submerged or emerged aquatic vegetation, overhanging banks/roots, leaf packs, large submerged wood, riffles, deep pools, etc.): Overhanging vegetation.			
Aquatic Organisms Observed (list): Frogs.			
Disturbances (ex: livestock access, manure in waterbody, waste discharge pipes): None.			
Observation Notes: The feature likely only carries flowing water after flooding/heavy rain events, and is erosional in nature.

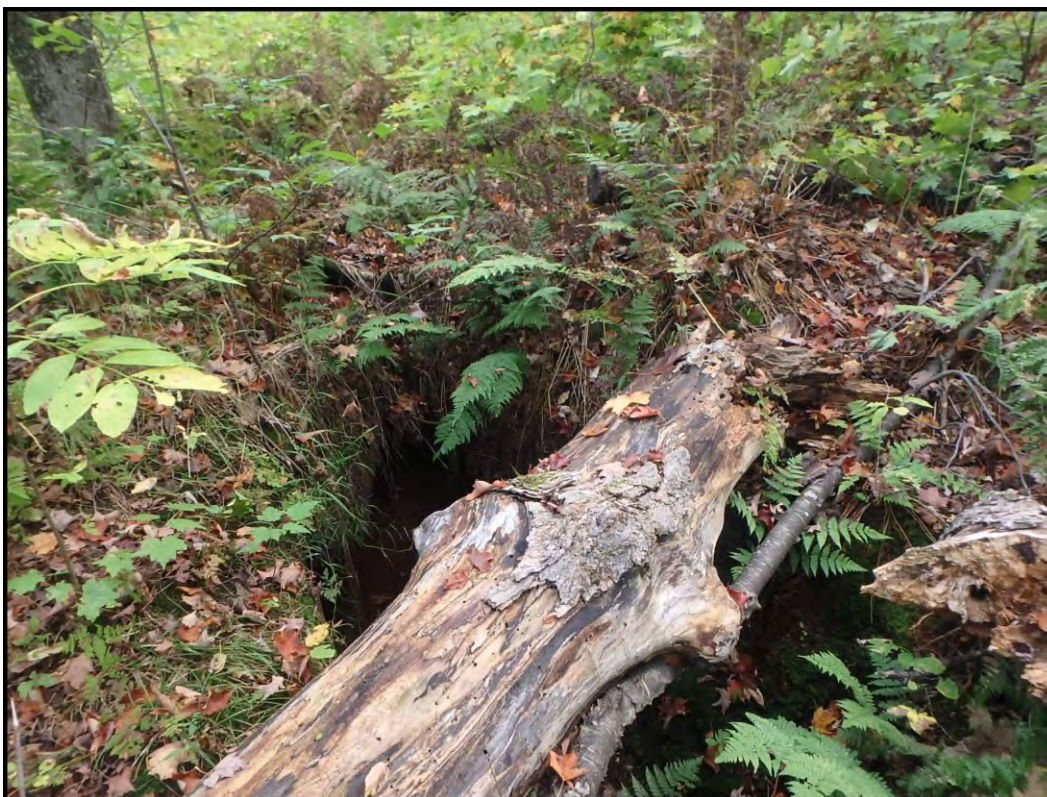
sirc004e_E (upstream)

Vegetation Layers: <input checked="" type="checkbox"/> Trees <input checked="" type="checkbox"/> Saplings/Shrubs <input checked="" type="checkbox"/> Herbs <i>(check all that apply)</i>			
Dominant Bank Vegetation (list): Fraxinus nigra, Acer saccharum, Prunus serotina, Dryopteris intermedia.			
Aquatic Habitats (ex: submerged or emerged aquatic vegetation, overhanging banks/roots, leaf packs, large submerged wood, riffles, deep pools, etc.): None.			
Aquatic Organisms Observed (list): None.			
Disturbances (ex: livestock access, manure in waterbody, waste discharge pipes): None.			
Observation Notes: The feature is erosional and has steep banks.

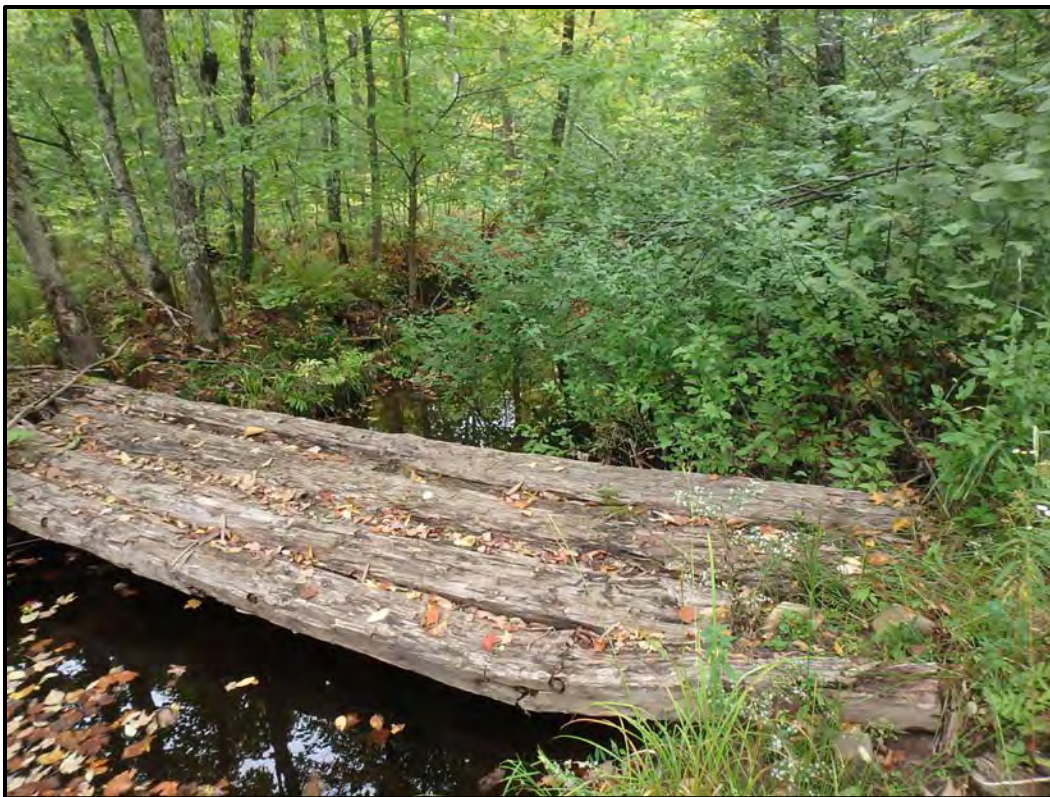
sirc002p_N (downstream)

Observations			
Riparian Zone Present: <input type="checkbox"/> Yes <input checked="" type="checkbox"/> No <small>(check one)</small>			
Vegetation Layers: <input checked="" type="checkbox"/> Trees <input checked="" type="checkbox"/> Saplings/Shrubs <input checked="" type="checkbox"/> Herbs <small>(check all that apply)</small>			
Dominant Bank Vegetation (list): Acer saccharum, Ulmus americana, Betula alleghaniensis, Fraxinus nigra, Alnus incana, Carex crinita, Scirpus hattorianus, Glyceria striata.			
Aquatic Habitats (ex: submerged or emerged aquatic vegetation, overhanging banks/roots, leaf packs, large submerged wood, riffles, deep pools, etc.): Pools, overhanging vegetation.			
Aquatic Organisms Observed (list): None.			
Disturbances (ex: livestock access, manure in waterbody, waste discharge pipes): Runoff from intersecting unpaved path.			
Observation Notes: Banks have been scoured by erosion and are approximately 1 foot high in places.

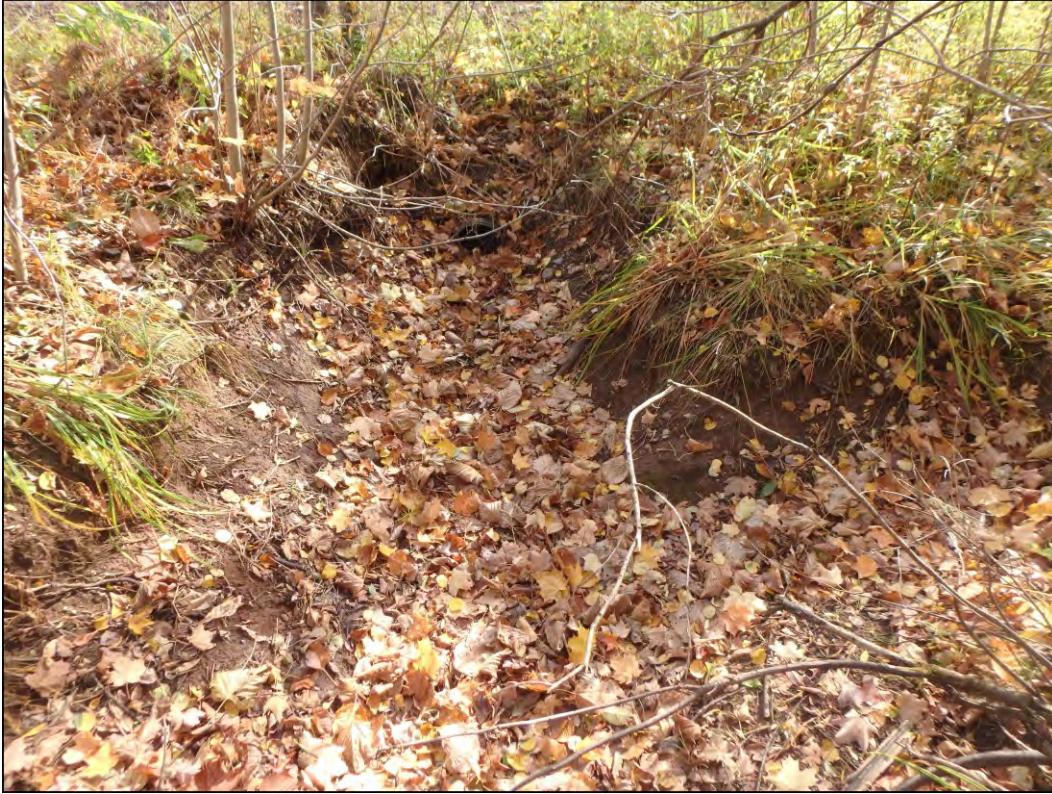
sird017e_E (upstream)

Observations			
Riparian Zone Present: <input type="checkbox"/> Yes <input checked="" type="checkbox"/> No <small>(check one)</small>			
Vegetation Layers: <input checked="" type="checkbox"/> Trees <input checked="" type="checkbox"/> Saplings/Shrubs <input checked="" type="checkbox"/> Herbs <small>(check all that apply)</small>			
Dominant Bank Vegetation (list): Acer saccharum, Tilia americana, Fraxinus nigra, Carex crinita, Athyrium filix-femina.			
Aquatic Habitats (ex: submerged or emerged aquatic vegetation, overhanging banks/roots, leaf packs, large submerged wood, riffles, deep pools, etc.): None.			
Aquatic Organisms Observed (list): None.			
Disturbances (ex: livestock access, manure in waterbody, waste discharge pipes): The banks of the feature have been eroded and the margins of the waterbody have been logged recently.			
Observation Notes: The waterbody receives water from the wetland to the east (wird040f). The surrounding buffer has been recently logged.

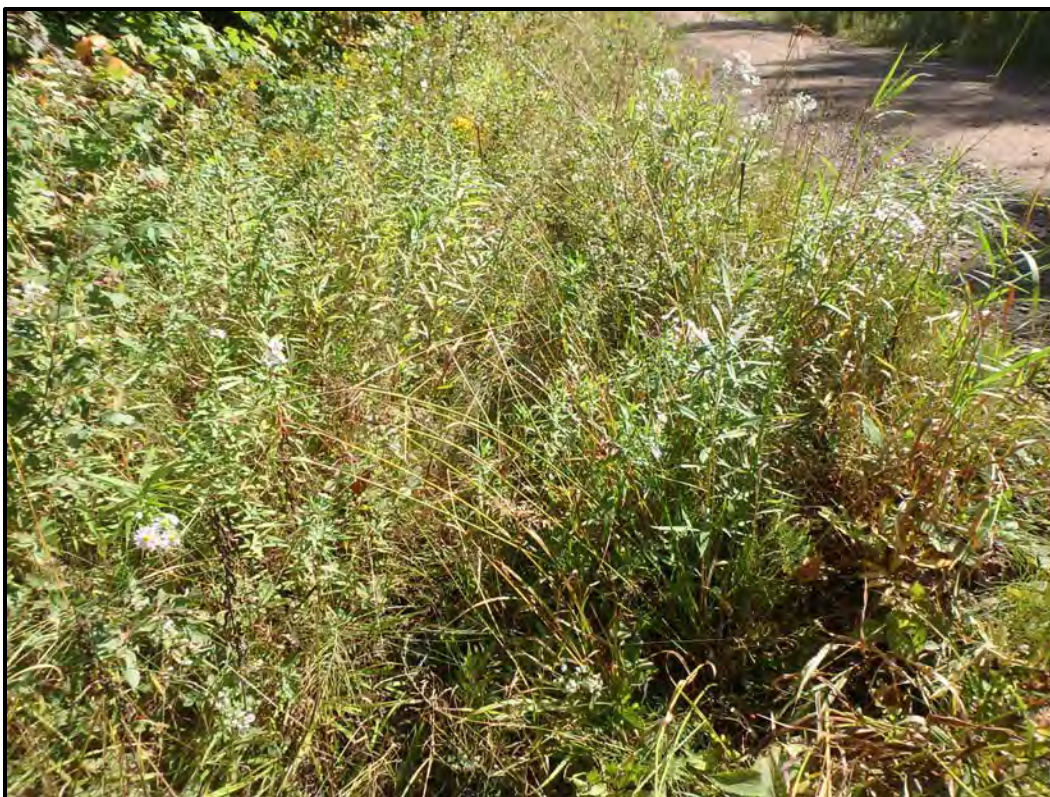
sirc001e_E (upstream)

Vegetation Layers: <input type="checkbox"/> Trees <input type="checkbox"/> Saplings/Shrubs <input checked="" type="checkbox"/> Herbs <small>(check all that apply)</small>			
Dominant Bank Vegetation (list): Scirpus hattorianus, Agrostis gigantea, Solidago gigantea.			
Aquatic Habitats (ex: submerged or emerged aquatic vegetation, overhanging banks/roots, leaf packs, large submerged wood, riffles, deep pools, etc.): None.			
Aquatic Organisms Observed (list): None.			
Disturbances (ex: livestock access, manure in waterbody, waste discharge pipes): Gravel road runoff.			
Observation Notes: None.

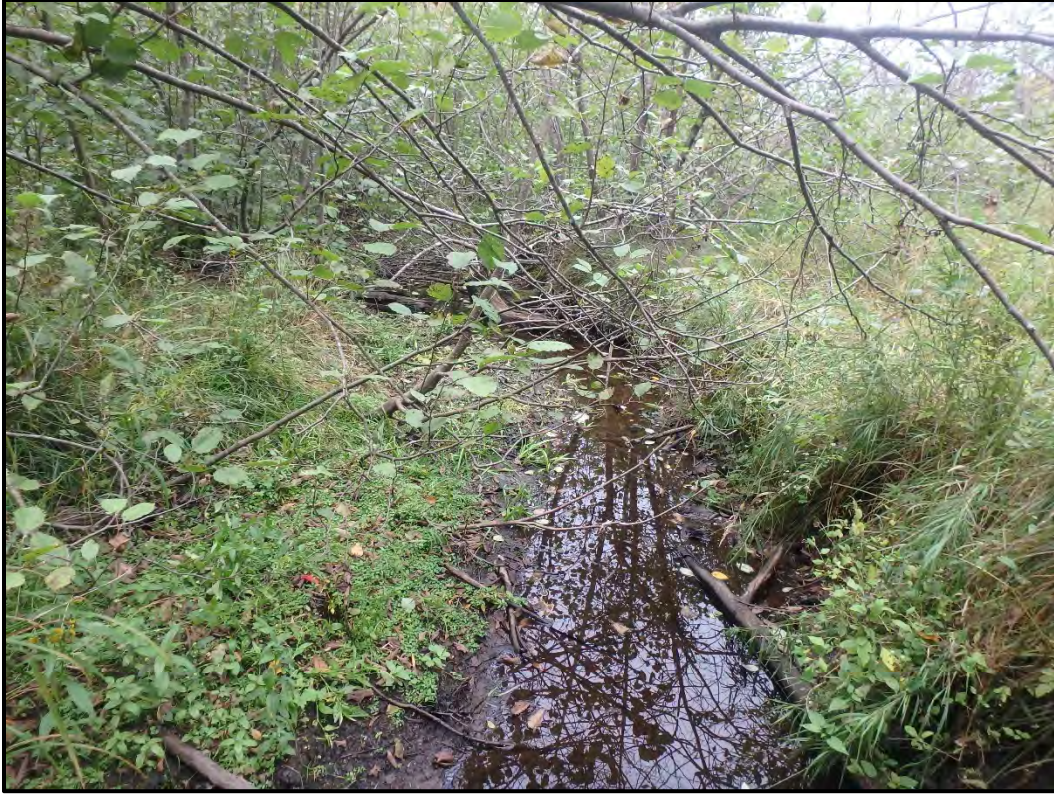
sira001i_E (downstream)

Observations			
Riparian Zone Present: <input checked="" type="checkbox"/> Yes <input type="checkbox"/> No <i>(check one)</i>			
Vegetation Layers: <input type="checkbox"/> Trees <input checked="" type="checkbox"/> Saplings/Shrubs <input checked="" type="checkbox"/> Herbs <i>(check all that apply)</i>			
Dominant Bank Vegetation (list): Ludwigia palustris, Carex crinita, Alnus incana, Carex lacustris, Cirsium arvense.			
Aquatic Habitats (ex: submerged or emerged aquatic vegetation, overhanging banks/roots, leaf packs, large submerged wood, riffles, deep pools, etc.): Pools of water surrounding waterbody.			
Aquatic Organisms Observed (list): Frogs, aquatic invertebrates.			
Disturbances (ex: livestock access, manure in waterbody, waste discharge pipes): Surrounding area has been heavily logged. Beaver activity around.			
Observation Notes: None.
